Manhole Inspection Summary

Manhole # S19II_011MH

Location Address: **1655 APPLETON-MONROE** Cross Street: **PRESBURY ST**

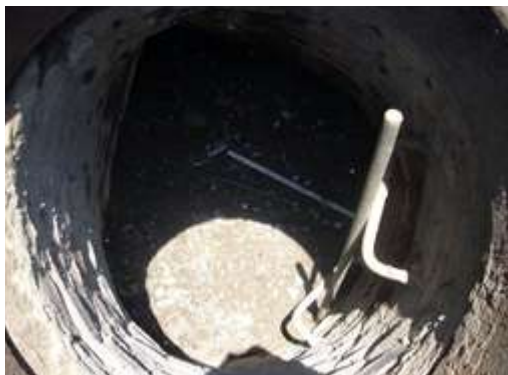
Top View

TERMINAL MANHOLE - HARD TO SHOW IN ONE PHOTO DUE TO ORIENTATION AND CONSTRUCTION

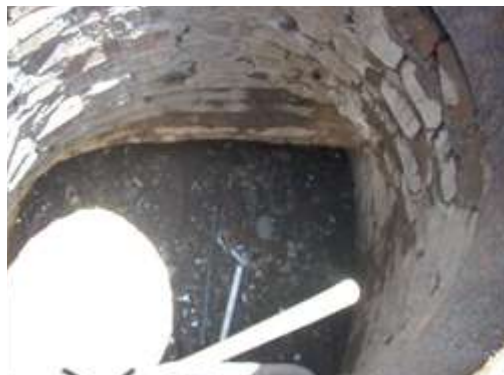
Defect 3

Bench ☒ Exists Material: **Brick** ☐ Parged
Condition: ☐ Sound ☐ Cracked ☐ Root Intrusion ☐ Deteriorated ☐ Leaks ☒ **Debris**

Channel Material: **Brick** ☐ Parged
Channel Exposure: **Fully Open** Junc Dist: **0** nearest .5 ft. Azimuth:
Condition: ☐ Sound ☐ Cracked ☐ Root Intrusion ☐ Deteriorated ☐ Leaks ☒ **Debris**

CHANNEL AND BENCH DEBRIS

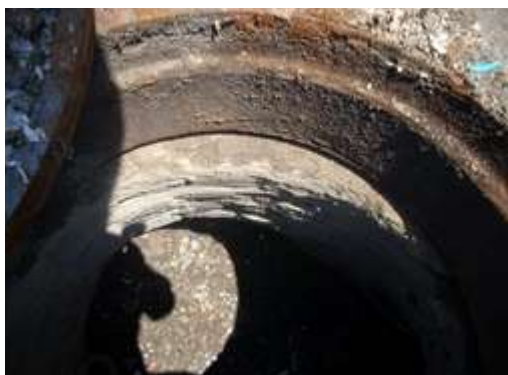
Defect 2

Frame Offset: **2** (in.) Condition: ☒ Sound ☐ Cracked ☐ Leaks

FRAME OFFSET

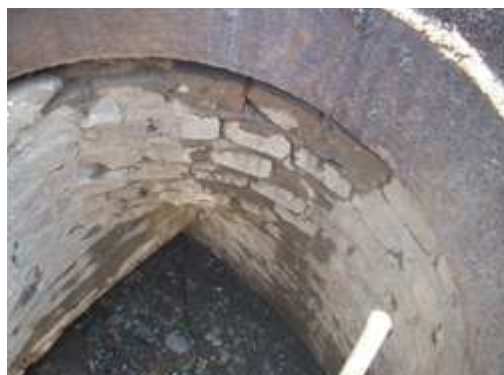
Defect 1

Corbel Material: **Brick** ☐ Parged Type: **Concentric/Eccentric**
Condition: ☒ Sound ☐ Cracked ☐ Root Intrusion ☐ Loose Brick ☐ Deteriorated
Infiltration: ☐ None ☒ **Joint** ☐ Cracks ☐ Mortar ☐ Roots ☐ Wall

INFILTRATION OF CORBEL

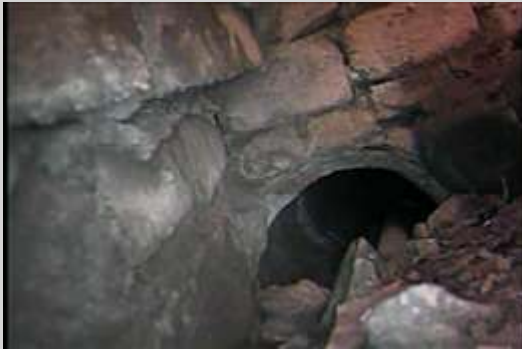
12 O'Clock Outflow

Pipe Height: **8.4** (in.) Rod and Bar (Angled)
Pipe Material: **Clay** ☐ Pipe Lined
Invert Depth: **5.79** (ft.) Flow Characteristics: **None**
Deposits: ☐ None ☐ Mud ☐ Sludge ☒ **Debris** ☐ Grease
Silt Depth: **3** (in.) Deposits Extent: **Heavy**
Infiltration: **None** Pipe Seal Cond: **Sound**

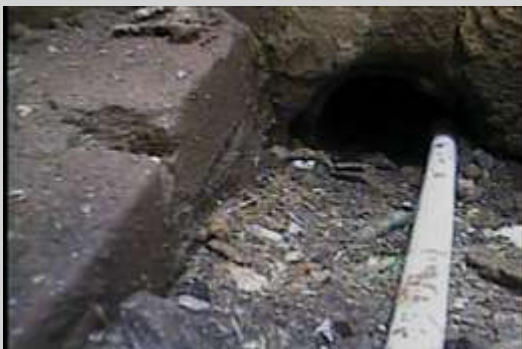
3 O'Clock Inflow

Pipe Height: **6** (in.) Rod and Bar (Angled)
Pipe Material: **Clay** ☐ Pipe Lined
Invert Depth: **5.28** (ft.) Flow Characteristics: **None**
Deposits: ☐ None ☐ Mud ☐ Sludge ☒ **Debris** ☐ Grease
Silt Depth: **3** (in.) Deposits Extent: **Heavy**
Infiltration: **None** Pipe Seal Cond: **Sound**

Connects To: **Stub connection / abandoned**
